CALSPAN ON-SITE AIR BAG DEPLOYMENT INVESTIGATION

CALSPAN CASE NO. 95-09

VEHICLE #1 - 1992 FORD TAURUS GL STATION WAGON (AIR BAG EQUIPPED)

VEHICLE #2 - 1989 CHEVROLET S10 PICKUP TRUCK

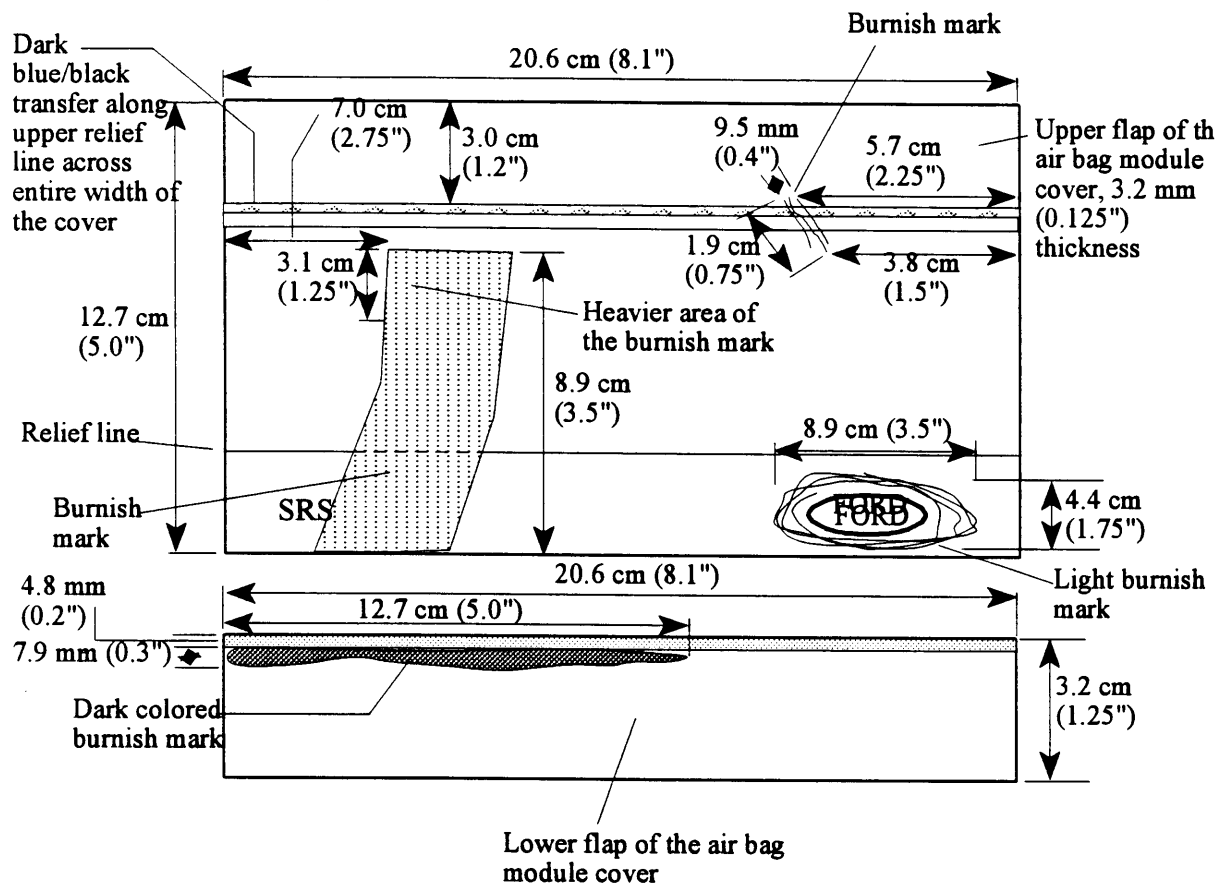
Driver Side Air Bag Module Cover

The air bag module flaps exhibited several burnish marks and fabric coloration transfer marks (refer to photographs #44 - #46 on pages A-22, A-23) from contact with the driver during the deployment sequence. A dark blue/black transfer was observed along the entire upper cosmetic relief line located 3.0 cm (1.2") below the top of the upper flap which was consistent in color with the color of the driver's shirt (refer to photographs #57, #58 on page A-29). A significant burnish mark which measured 8.9 cm (3.5") vertically and 3.1 cm (1.25") laterally was located 3.1 cm (1.25") right of the left vertical tear seam and began at the horizontal tear seam line.

A small burnish mark measuring 1.9 cm (0.75") long and 9.5 mm (0.4") wide was oriented in an angular direction on the upper module flap with the upper point located 5.7 cm (2.25") left from the right vertical tear seam line and the lower point located 3.8 cm (1.5") left from the right tear seam line. There was a light burnish mark around the "Ford" insignia located in the bottom right corner of the upper module flap.

The lower air bag module flap exhibited a dark color burnish mark along the horizontal seam line (refer to photographs #47, #48 on page A-24). The mark measured 12.7 cm (5.0") laterally and 7.9 mm (0.3") vertically and began at the left vertical tear seam line. Refer to the diagram on the page 12 for a detailed schematic of the contact evidence on the driver side air bag module cover. The right side of the flap was displaced forward beyond the steering wheel rim as the result of the air bag deployment sequence and the loading by the unrestrained driver on the air bag (refer to photographs #47, #48 on page A-24).

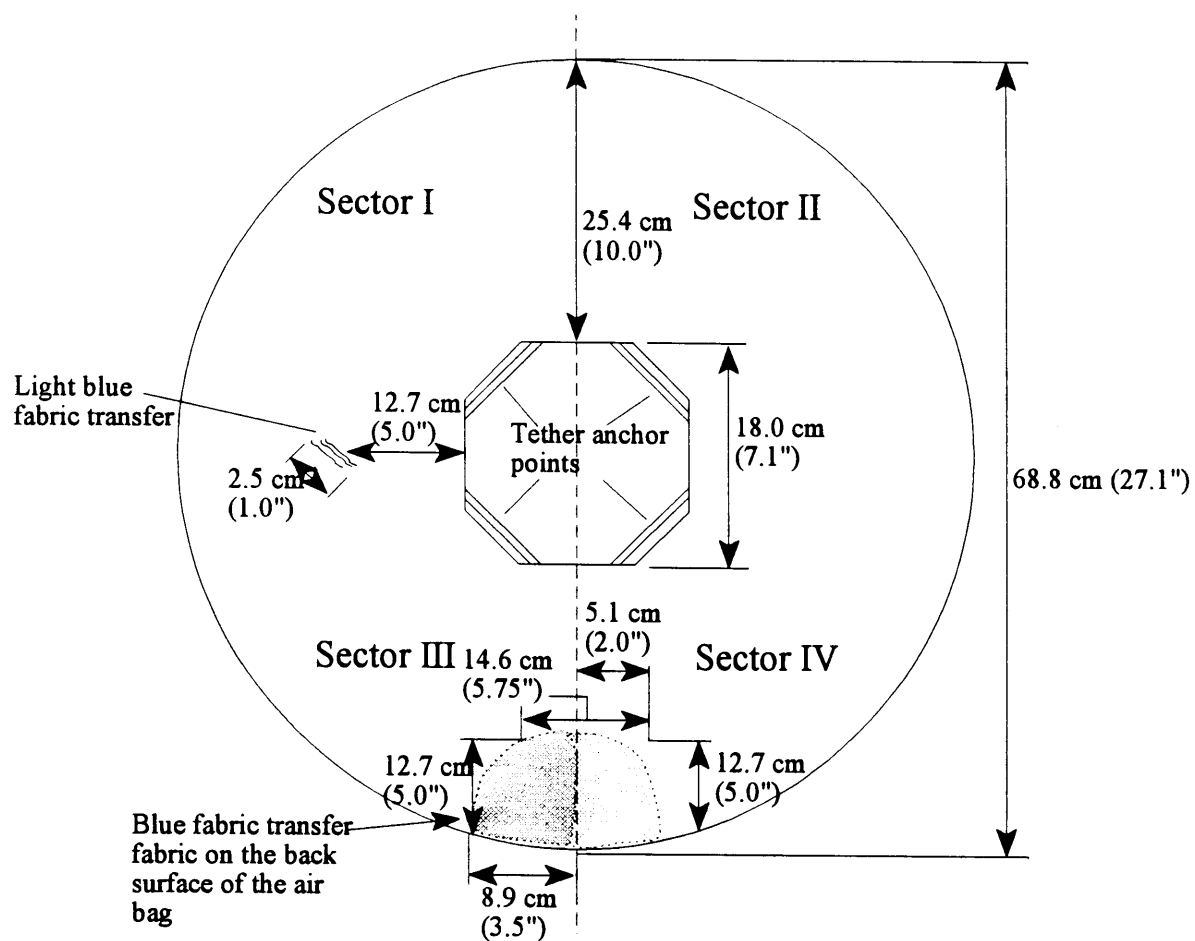
Front Surface of The Driver Side Air Bag

The driver air bag exhibited fabric transfers consistent in color with the color of the driver's shirt (refer to photographs #49, #50 on page A-25). A 2.5 cm (1.0") long light blue transfer was noted on the front surface of the air bag located 12.7 cm (5.0") left of the center target area. A large blue/gray fabric transfer measuring 14.6 cm x 12.7 cm (5.75" x 5.0") was noted on the back surface of the air bag in the six o'clock sector. It was located along the perimeter of the air bag and had an appearance of a heavier transfer coloration along the left side of the transfer pattern (refer to air bag diagrams on pages 13-14 for detailed documentation). This transfer resulted from

contact with the driver's abdominal area as noted by the multiple abrasions and contusions medically diagnosed.

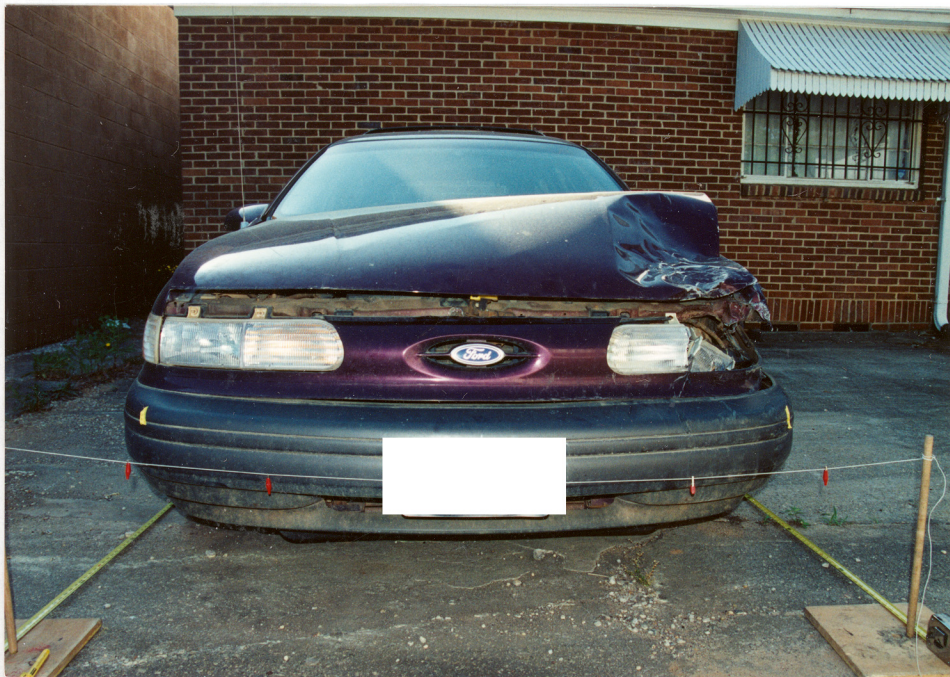
The frontal plane of the 1992 Ford Taurus GL station wagon struck the frontal plane of the 1989 Chevrolet S10 pickup truck. Direct contact was noted at the left front corner of the bumper surface, grille, and hood area. The front bumper sustained a maximum rearward displacement of 3.8 cm (1.5") and the left corner of the hood was displaced rearward a maximum of 38.1 cm (15.0"). The combined direct and induced damage length measured 139.7 cm (55.0") (refer to photographs #18, #19, #22 - #25 on pages A-9, through A-13). Measured crush values are listed below:

18. Frontal view of the 1992 Ford Taurus GL station wagon (Vehicle #1) showing the overall plane of contact.

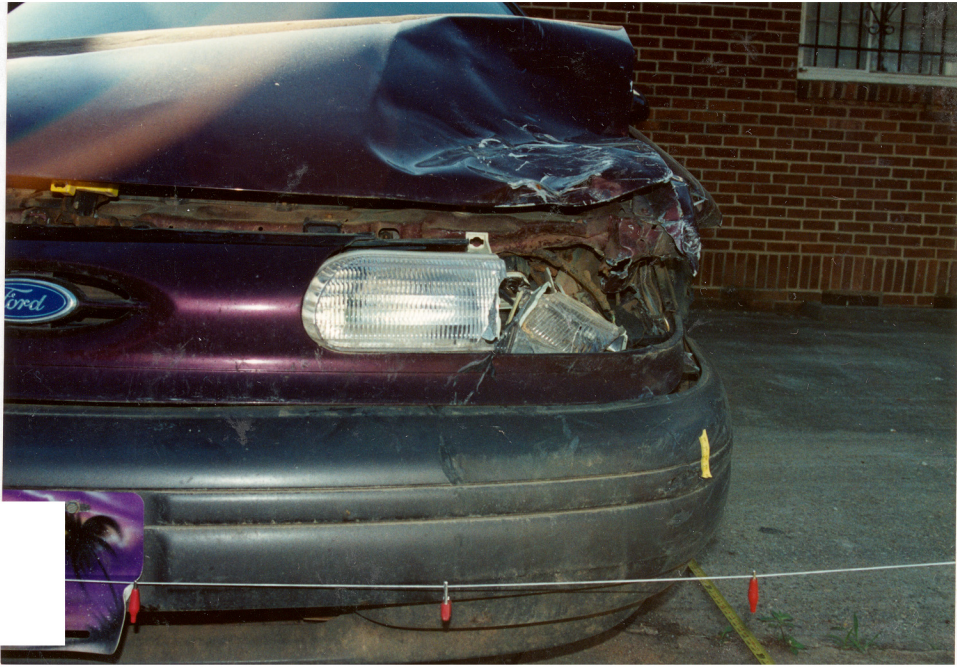
Components damaged in the crash included: the front bumper fascia, the grille; the left headlight and directional light assembly; the hood; the left front fender; the radiator; and the windshield. The left front bumper energy absorption device (EAD) was displaced rearward the full stroke value of 5.1 cm (2.0") with full restitution while the right EAD was not displaced (refer to photographs #29, #30 on page A-15).

19. Closer view of the contact damage along the left front bumper, grille, and hood.

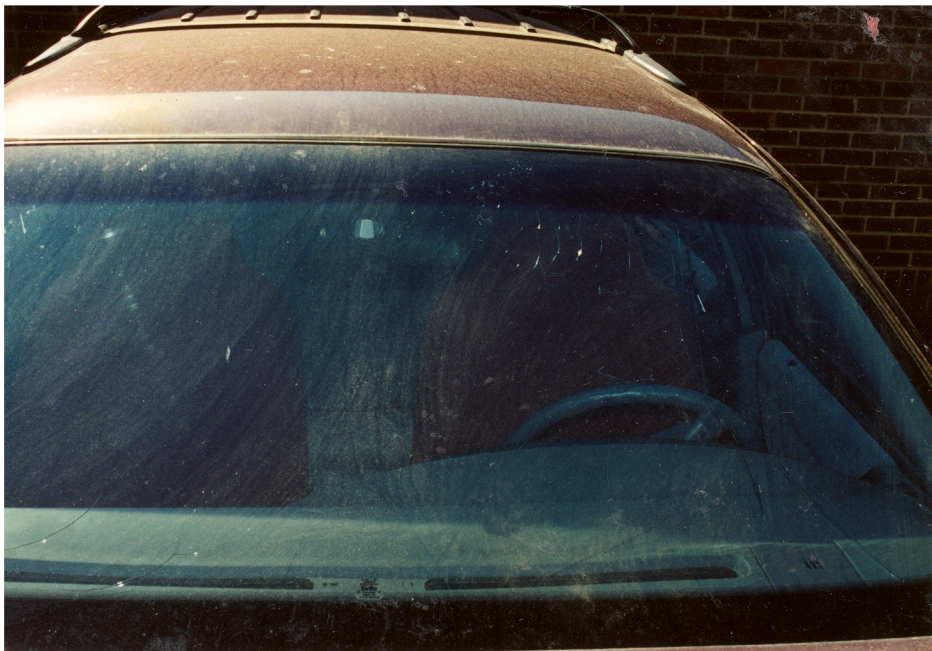
The windshield exhibited a spider web contact pattern which was consistent with an occupant hand contact. It was located 21.6 cm (8.5") left of the vehicle centerline and 11.1 mm (0.4") below the windshield header. Although the driver did not report any correlating lesion, this damage was probably caused by contact of the driver's right hand during the crash.

20. View of interior contact evidence on the windshield near the windshield header.

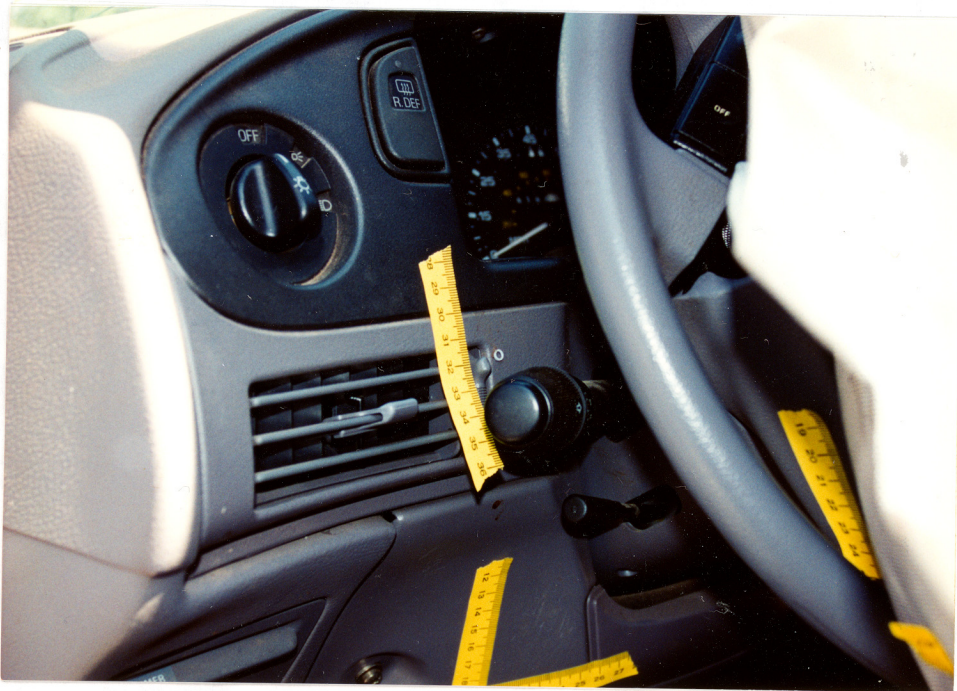
A light color transfer mark was noted on the mid instrument panel 55.2 cm (21.75") left of the vehicle centerline (refer to photograph #37 on page A-19). This was associated with a contact by the driver's left hand.

37. View of contact evidence on the instrument panel and knee bolster.

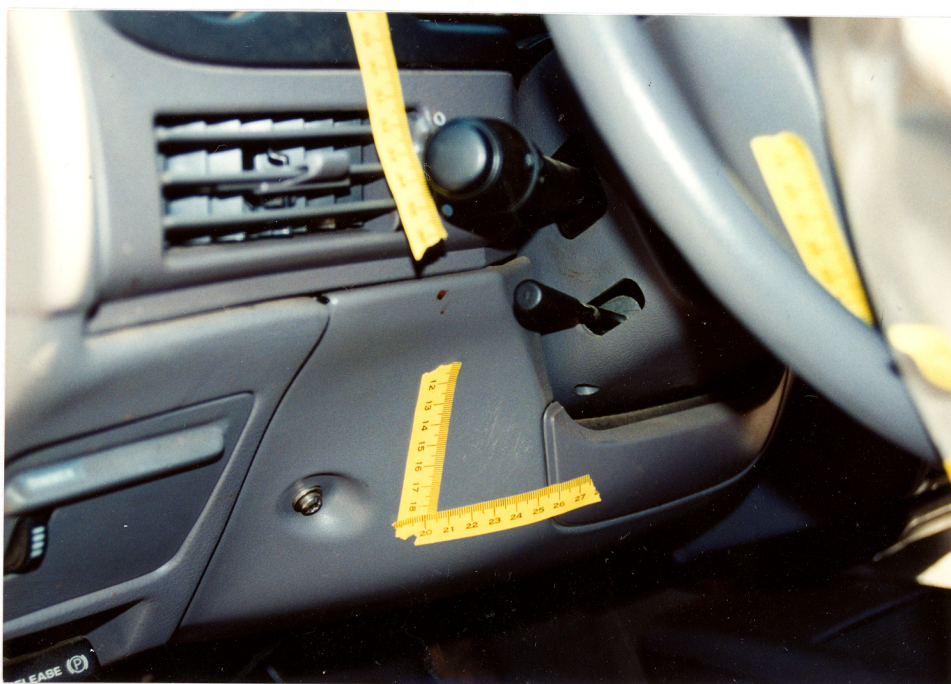
38. Close-up view of contact evidence on the knee bolster.

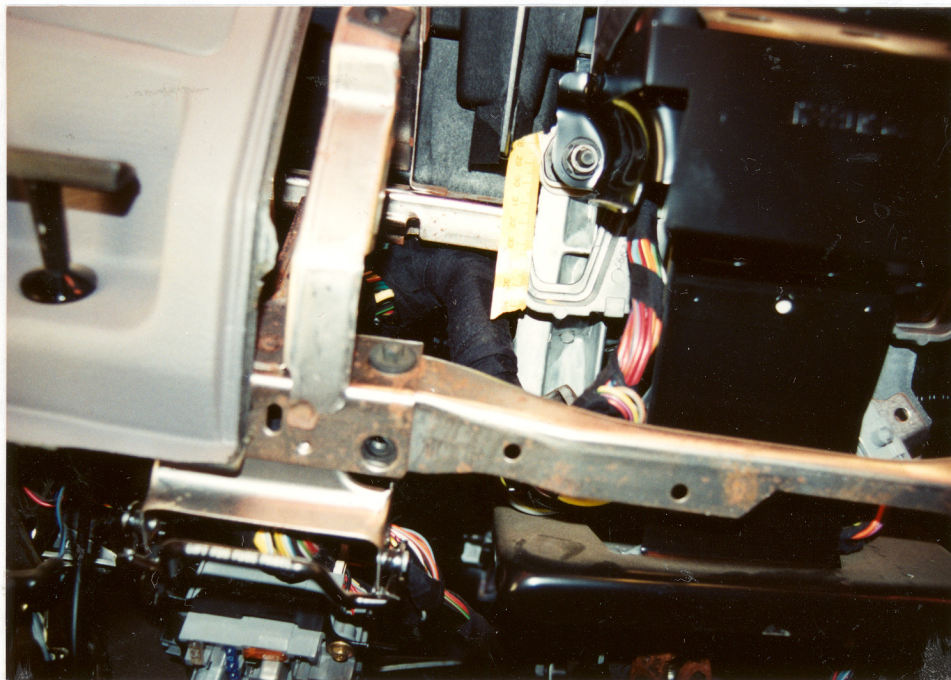
The driver continued to move forward due to the crash force and compressed the steering column energy absorption device. This was noted by the movement of the steering column shear plate which measured 4.8 cm (1.875") of displacement at the left shear capsule and 3.8 cm (1.5") at the right shear capsule. As the air bag system initiated the deployment sequence, the module cover flaps pushed against the driver's abdominal area in response to the expanding air bag. The air bag then contacted her abdominal region.

39. View of the left shear capsule showing the movement of the shear plate.

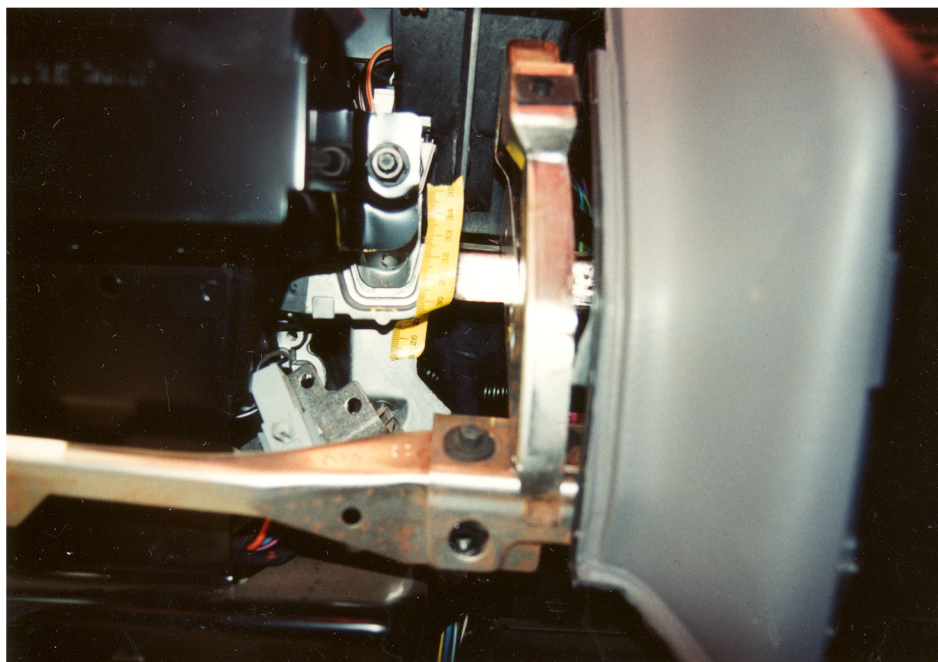
In response to this braking, the driver moved forward and came in contact with the driver's side air bag module cover. She continued to move forward due to the crash force and compressed the steering column energy absorption device. This was noted by the movement of the steering column shear plate which measured 4.8 cm (1.875") of displacement at the left shear capsule and 3.8 cm (1.5") at the right shear capsule.

40. View of the right shear capsule showing the movement of the shear plate.

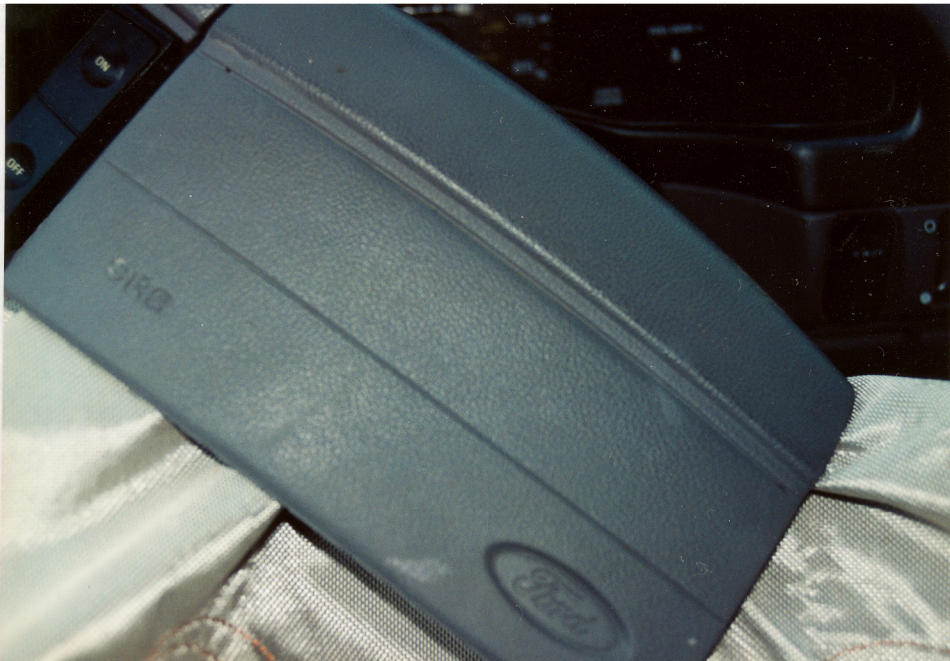
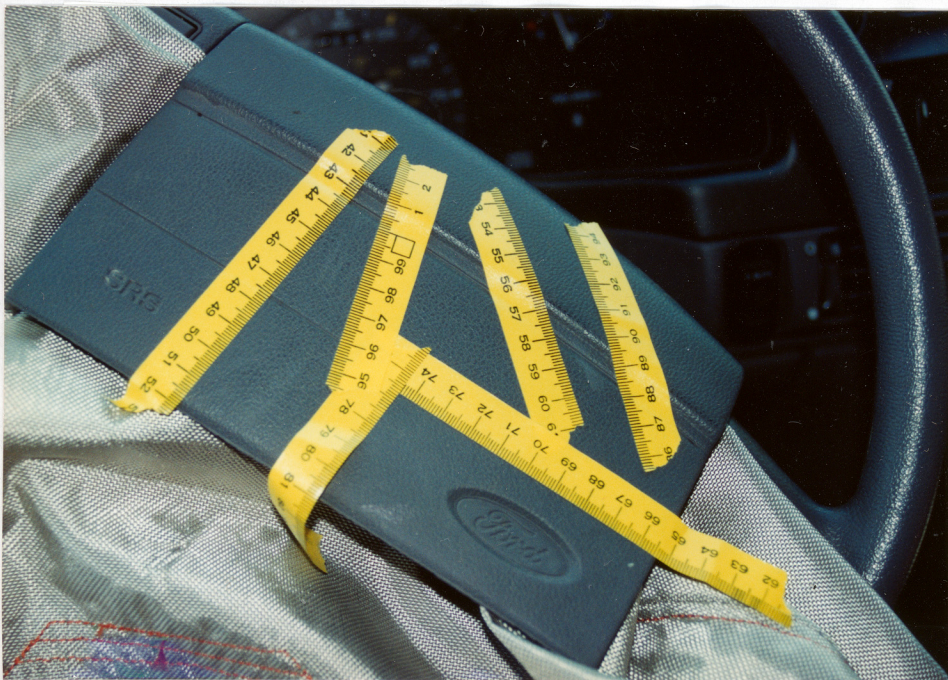
Damage to the interior was associated with driver contacts. The driver side air bag module cover exhibited several burnish marks and fabric coloration transfers (refer to photographs #44 - #46 on pages A-22, A-23). A dark blue/black transfer was observed along the entire upper cosmetic relief line which was located 3.0 cm (1.2") below the top of the upper flap. This transfer was consistent in color with the color of the driver's shirt (refer to photographs #57, #58 on page A-29).

A large burnish mark measuring 8.9 cm (3.5") vertically from the horizontal tear seam line and extending 3.1 cm (1.25") laterally was located 3.1 cm (1.25") right of the left vertical tear seam. A small burnish mark measuring 1.9 cm (0.75") long and 9.5 mm (0.4") wide was oriented in an angular direction with the upper point located 5.7 cm (2.25") from the right vertical tear seam line and the lower point located 3.8 cm (1.5") from the right tear seam line. There was a light burnish mark around the "Ford" insignia located in the bottom right corner of the upper module flap.

45., 46. Views of the driver side air bag module cover before and after the application of the calibrated tape.

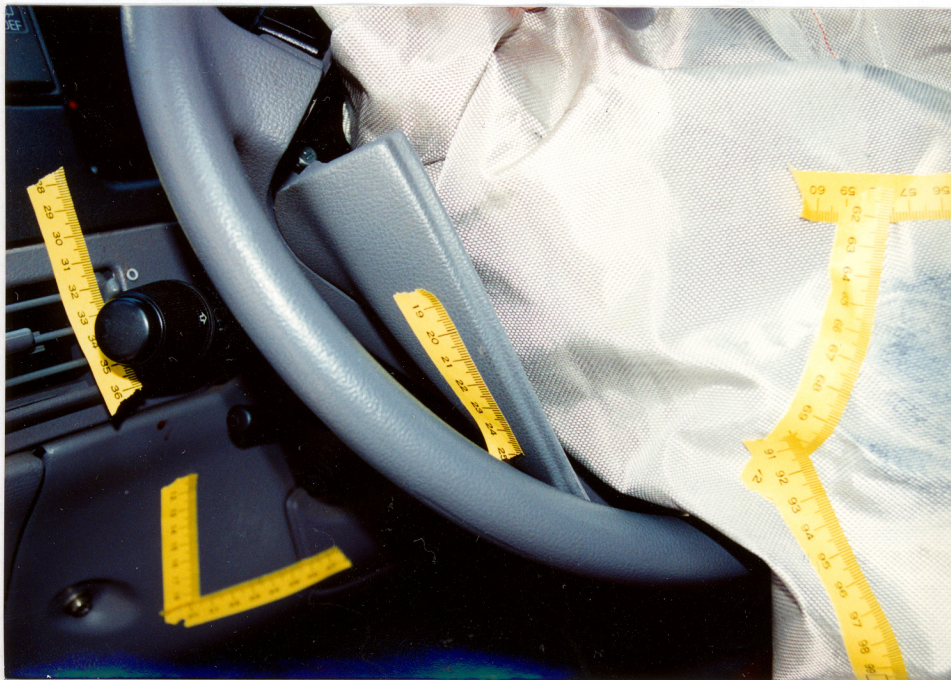
The lower air bag module flap exhibited a dark color burnish mark along the horizontal seam line (refer to photographs #47, #48 on page A-24). The mark measured 12.7 cm (5.0") laterally and 7.9 mm (0.3") vertically and began at the left vertical tear seam line. Refer to the diagram on page 12 for a detailed schematic of the contact evidence on the driver side air bag module cover.

47., 48. Views showing the position of the lower air bag module flap and the contact evidence along the horizontal tear seam line of the flap.

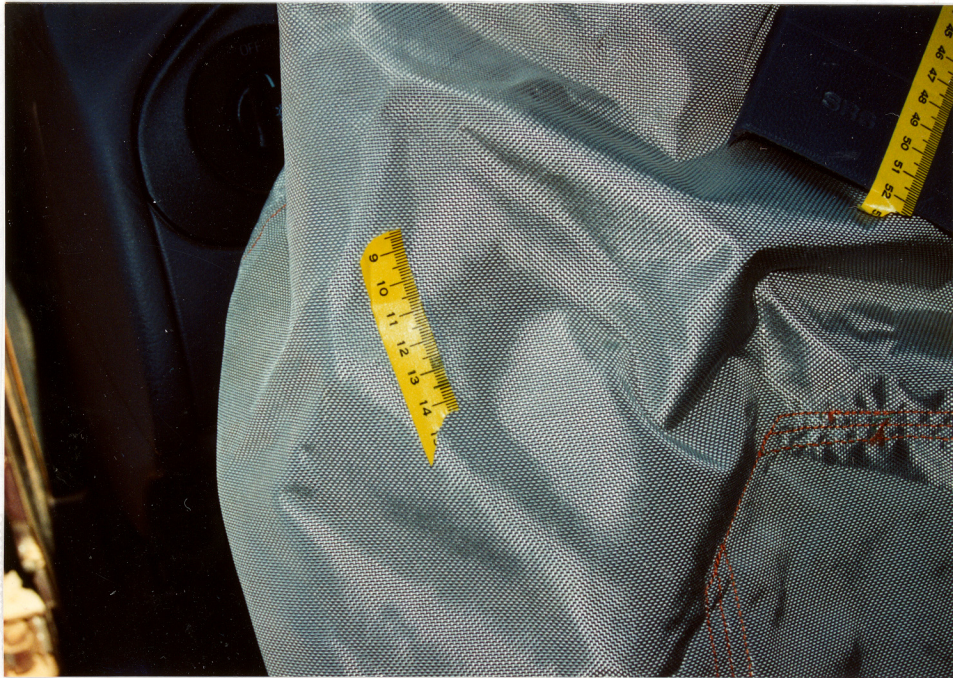
The driver air bag exhibited transfers which were consistent in color with the color of the driver's shirt (refer to photographs #49, #50 on page A-25). A 2.5 cm (1.0") long light blue transfer was noted on the front surface of the air bag located 12.7 cm (5.0") left of the center "target" area. A large blue/gray fabric transfer measuring 14.6 cm x 12.7 cm (5.75" x 5.0") was noted on the back surface of the air bag in the six o'clock sector. It was located along the perimeter of the air bag and had an appearance of a heavier transfer coloration along the left side of the transfer (refer to air bag diagrams on pages 13-14 for detailed documentation). This transfer resulted from contact with the driver's abdominal area.

49. View showing a small linear blue transfer mark on the front surface of the air bag.

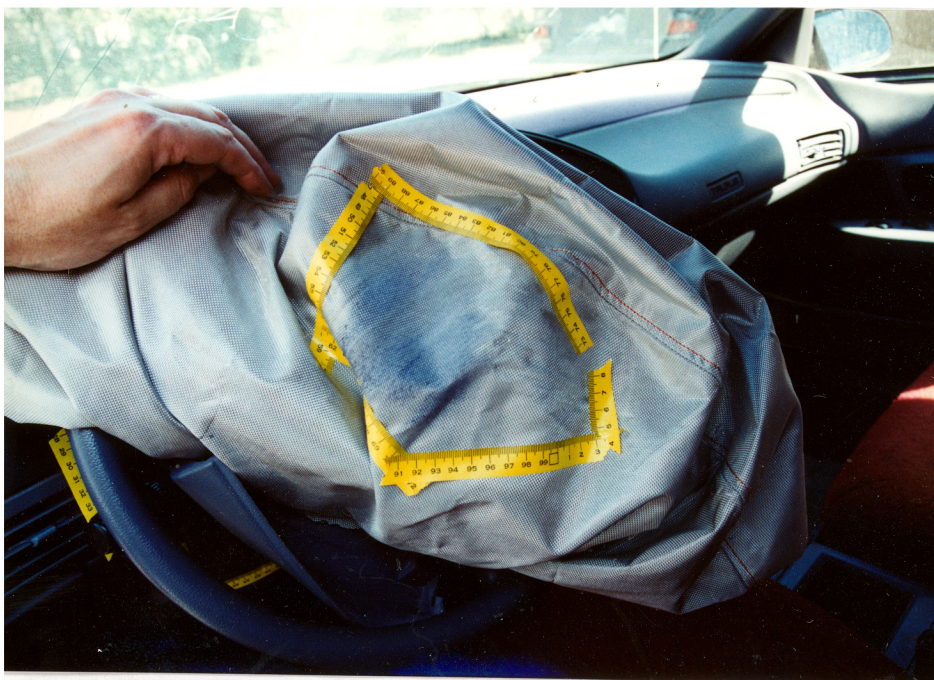
50. View of the large blue/black color transfer mark on the reverse side of the air bag.

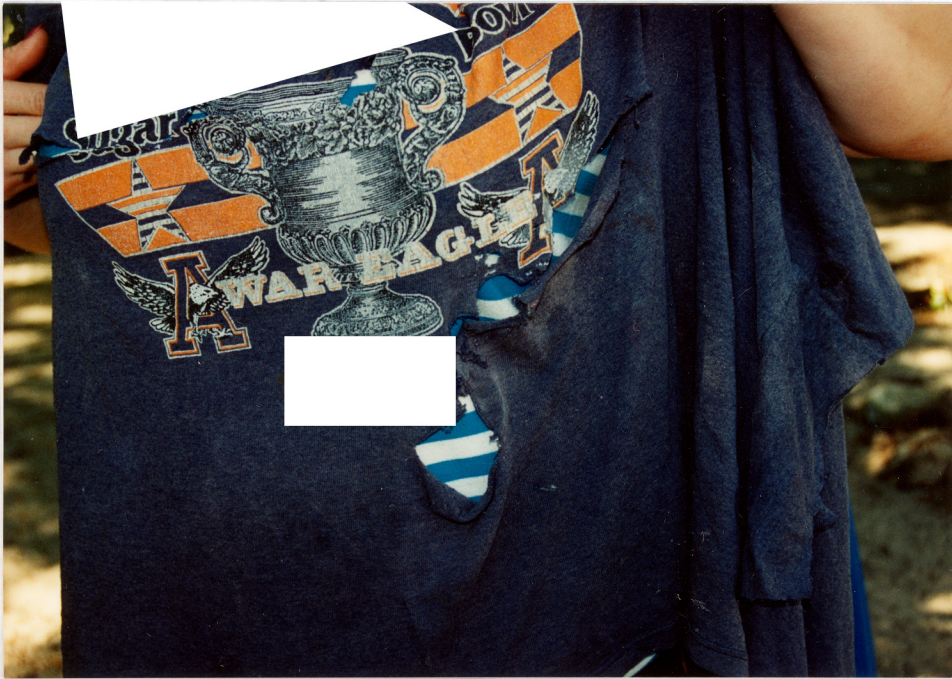
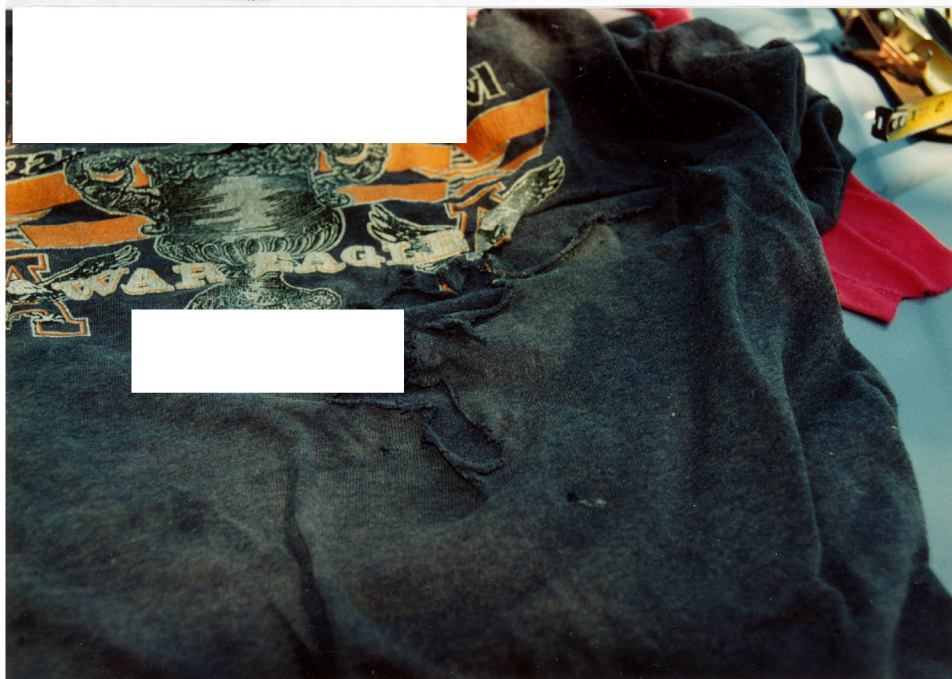
The driver was wearing a dark blue 100 percent cotton pullover shirt with a black and silver trophy cup designer logo on the front side. The garment was ripped in an area over the left side of the chest which resulted from contact by the upper air bag module flap during the supplemental restraint system (SRS) deployment. A blue and gray fabric transfer mark measuring 12.7 cm (5.0") x 14.7 (5.8") was noted on the instrument panel side of the air bag in the 6 o'clock position which was consistent with the color of the driver's shirt.

57., 58. Close-up views showing the tear pattern located along the lower left side adjacent to the word "Orleans" and the surrounding discoloration resulting from contact with the air bag during deployment.

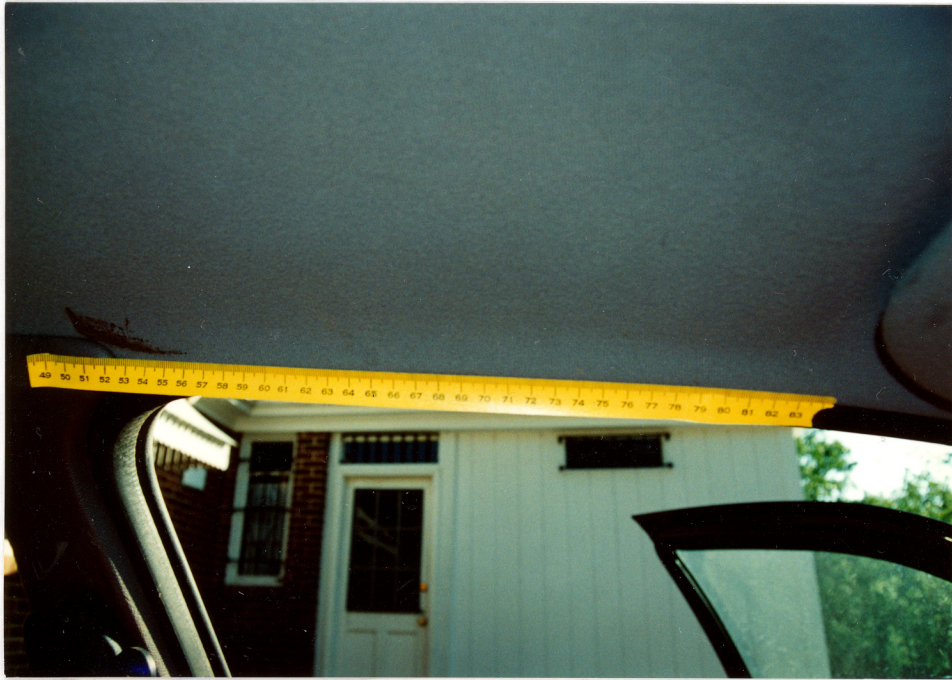
upper torso was then elevated upward and propelled rearward by the expanding air bag. A dark transfer mark was noted on the fabric along the left roof side rail which was attributed to contact by the driver's head as she was propelled rearward. The driver complained of bruising along the top of her head.

65. Close-up view of contact evidence along the left side roof rail.

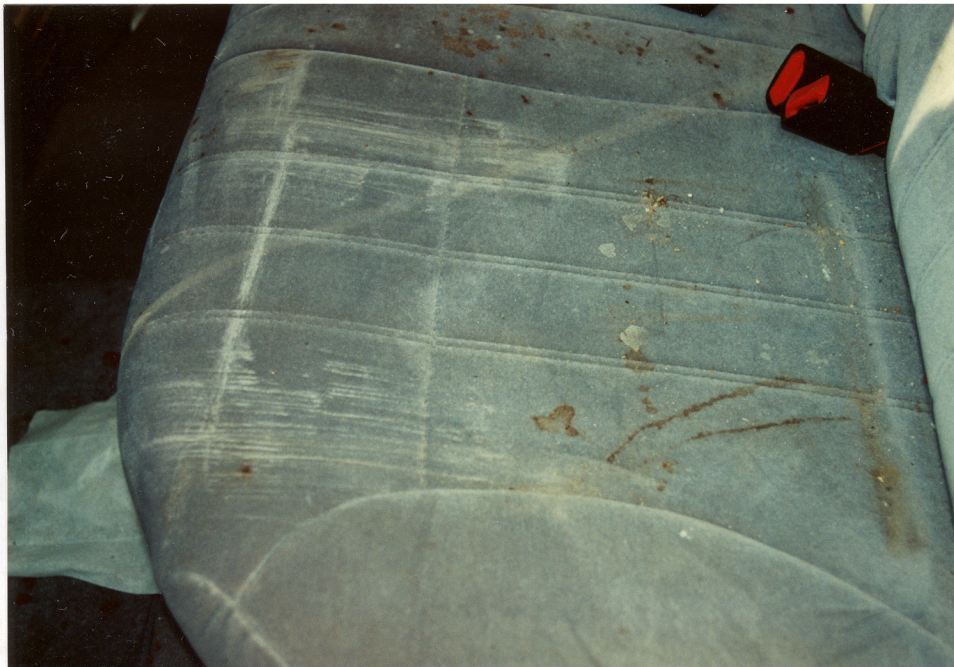
Other interior damage not related to the crash was noted to the left rear seat cushion. The driver indicated the abrasions on the seat fabric were related to the child safety seat used by her three year old son (refer to photograph #68 page A-34).

68. View of the left rear seat cushion showing abrasion of the seat fabric consistent with the installation and use of a child safety seat.

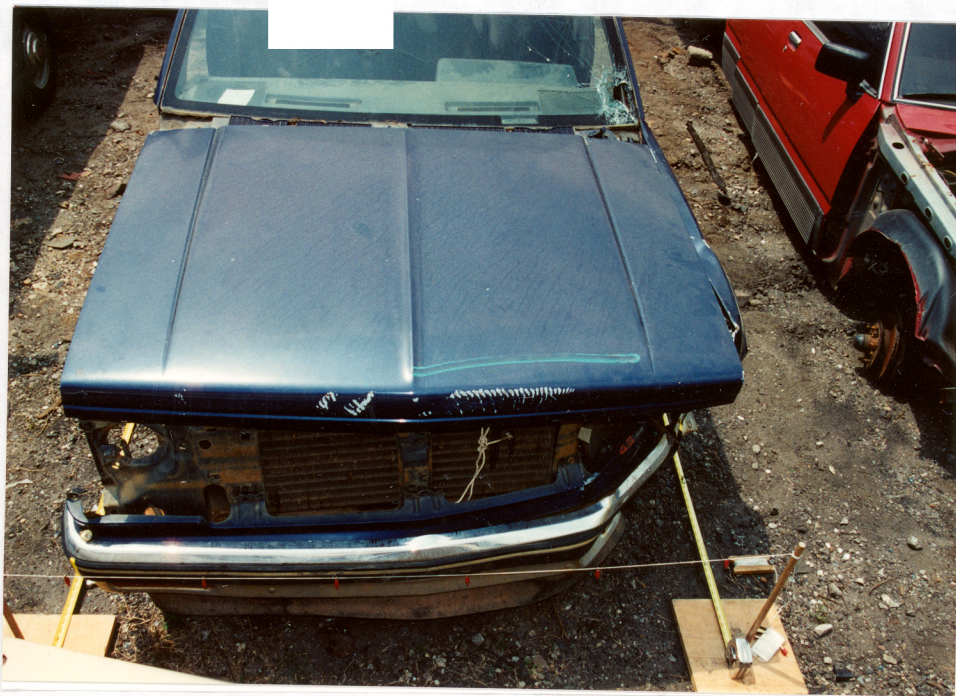
The frontal plane of the 1989 Chevrolet S10 pickup truck struck the frontal plane of Vehicle #1. The length of direct contact on the front bumper measured 38.1 cm (15.0"). The maximum crush of 31.75 cm (12.5") was located at the left front bumper corner. The crush pattern was typical of an off-set frontal impact configuration with deformation concentrated along the left frontal section of the vehicle (refer to photographs #69, #72 - #74 on pages A-35, A-36, A-37). The length of the direct and induced damage measured 143.5 cm (56.5") with crush values as listed below:

69. Frontal view of the 1989 Chevrolet S10 pickup truck (Vehicle #2) showing the overall plane of contact .

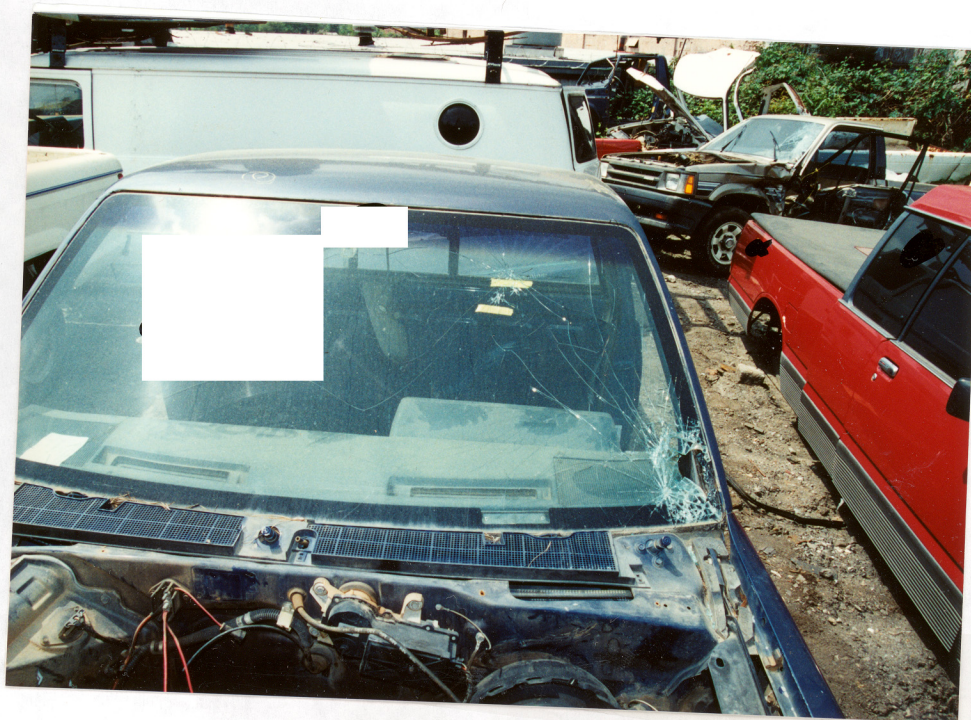
The windshield had two focal spider web pattern fractures which were typical of contact points. One was located 32.4 cm (12.75") left of the vehicle centerline and 12.7 cm (5.0") below the windshield header and the other fracture was located nearby at 29.8 cm (11.75") left of the centerline and 19.1 cm (7.5") below the windshield header. These were attributed to contact by the driver's right hand. There was a hole in the windshield glazing located at the lower left corner adjacent to the upper A-pillar and instrument panel. This resulted from contact by the left rear corner of the hood as it was displaced rearward during the crash.

70. View of the damage noted on the windshield.

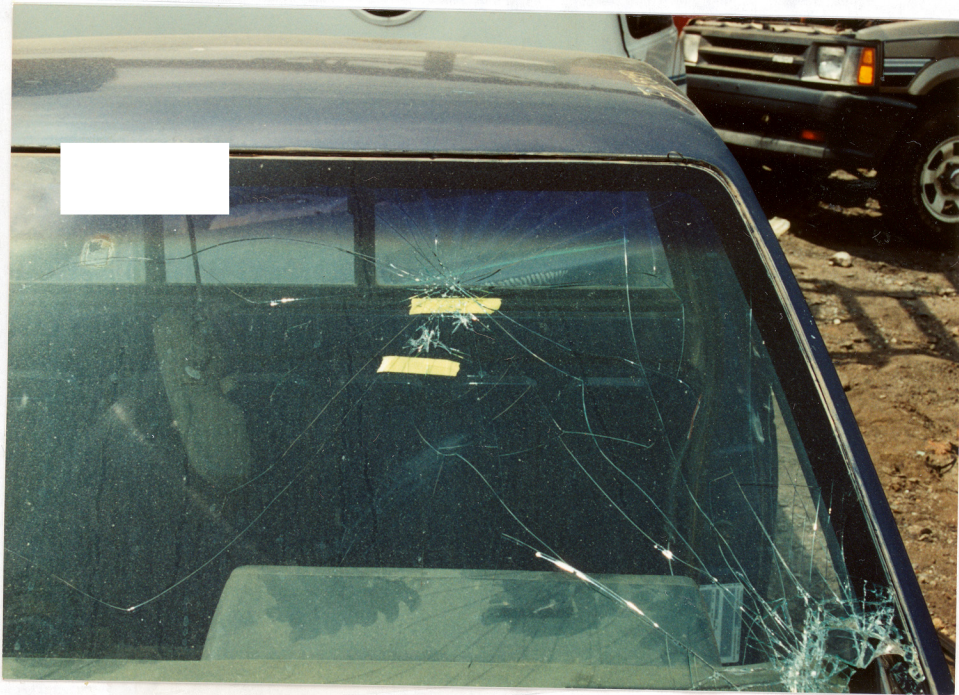
71. Close-up view of contact damage to the windshield.

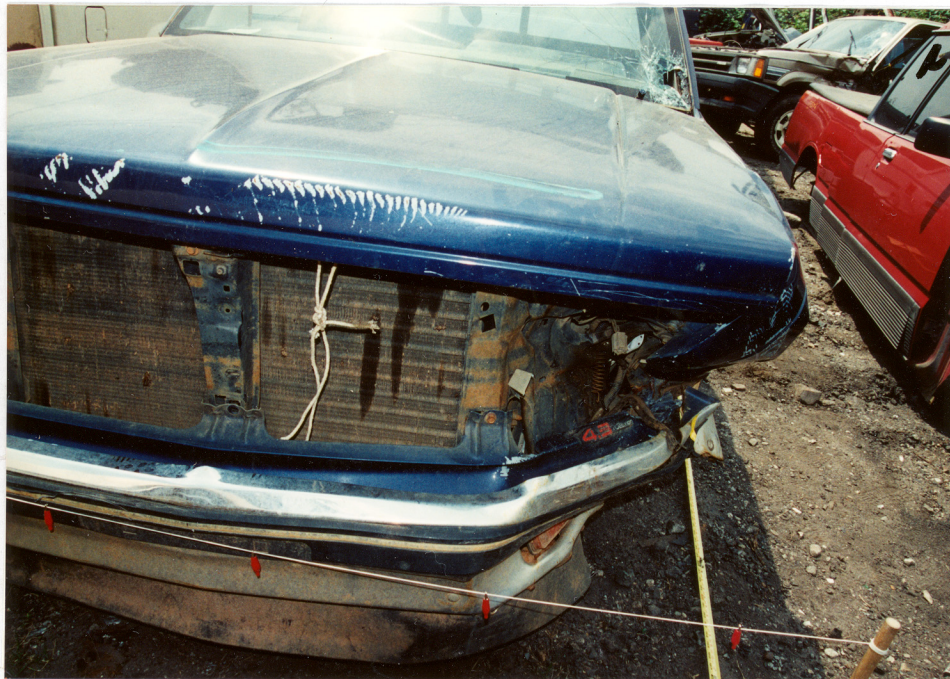
Components damaged in the crash included the front bumper, the left headlight and directional light assembly, the hood, grille, radiator, left front fender, and the windshield.

72. View of the left frontal area showing crash damage.

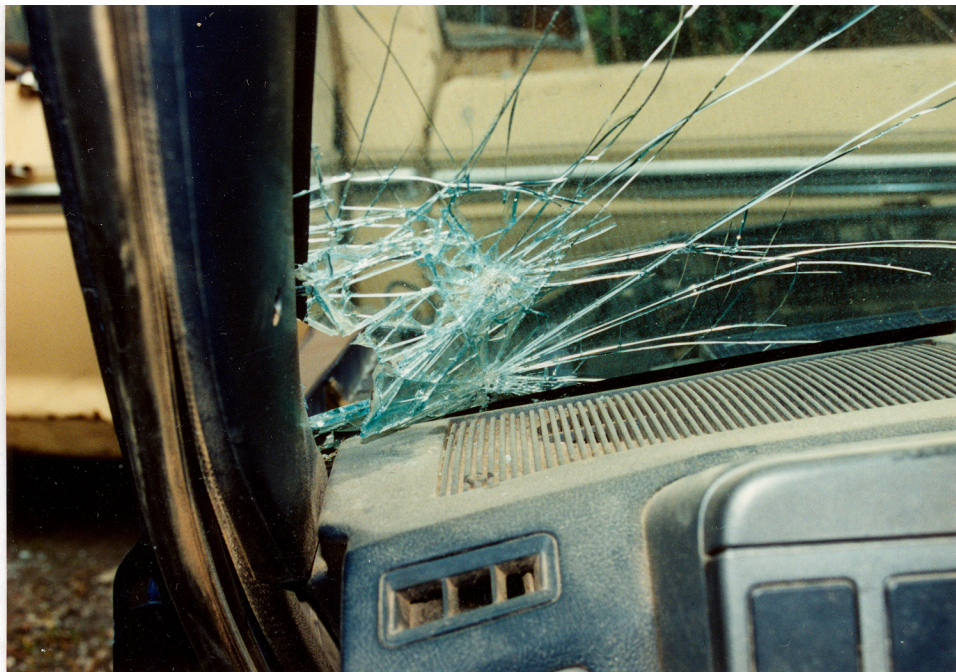
84. Close-up view of the hole in the windshield glazing.
